MAISON DOUCET HENNESSY HOUSE BATHURST, NEW BRUNSWICK

Architectural Description and Proposed Restoration

January 15, 2012

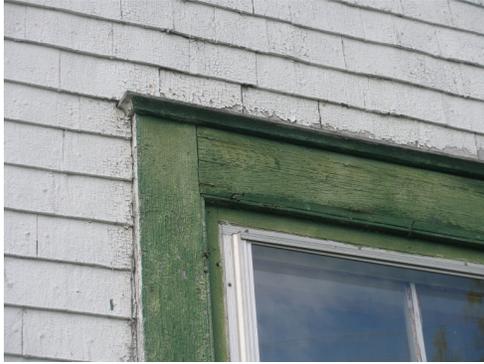
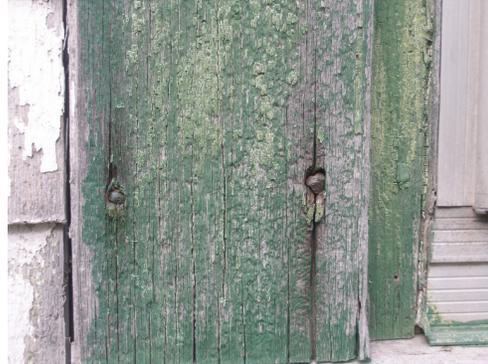
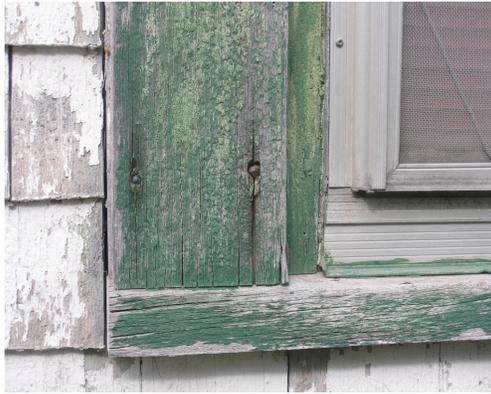
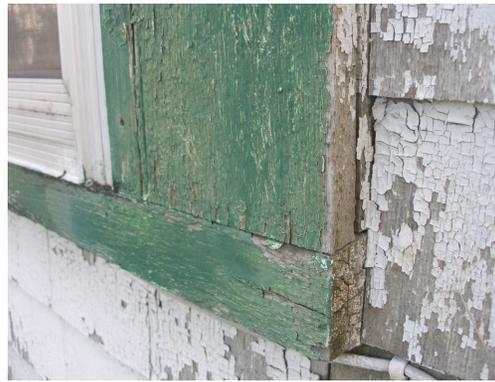
Exterior window frame of the front portion of the house.

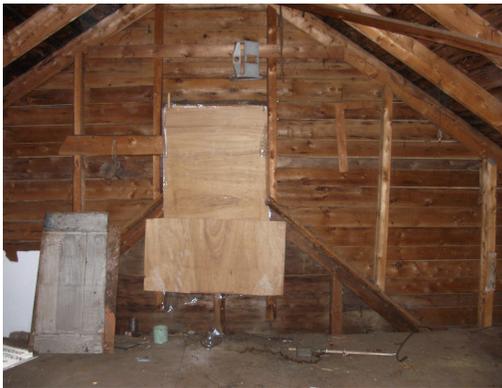
Evidence of the pitch roof framing of the first house in 1858.

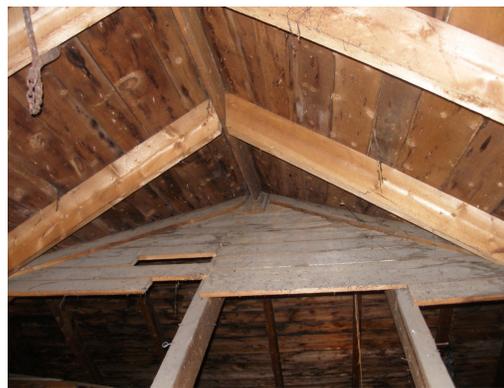
Evidence that both roofs has been built at the same time. No trace of shingle nails.

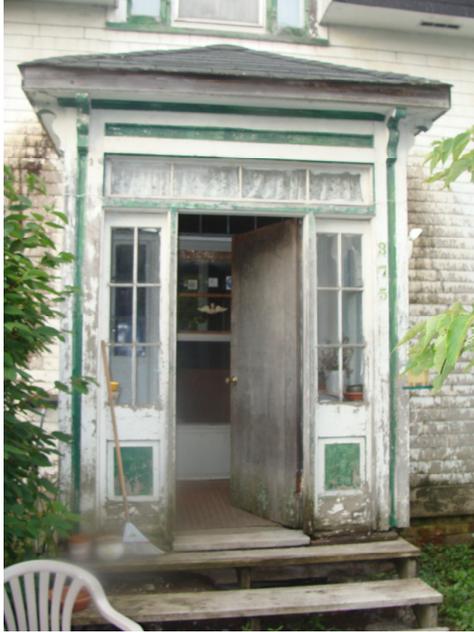
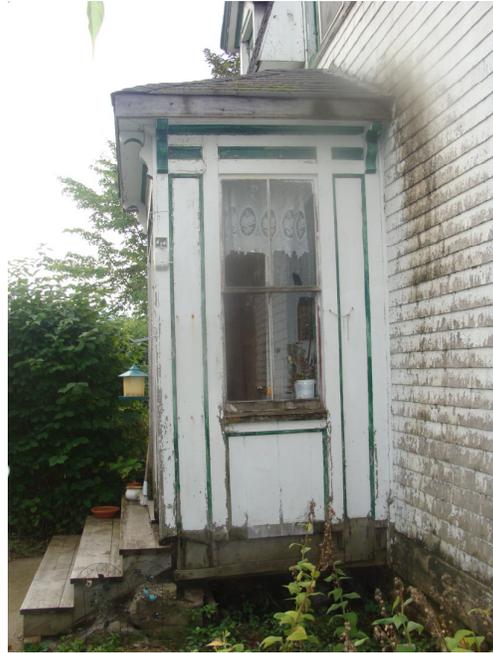
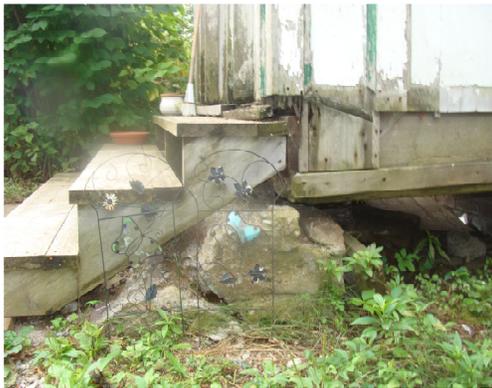
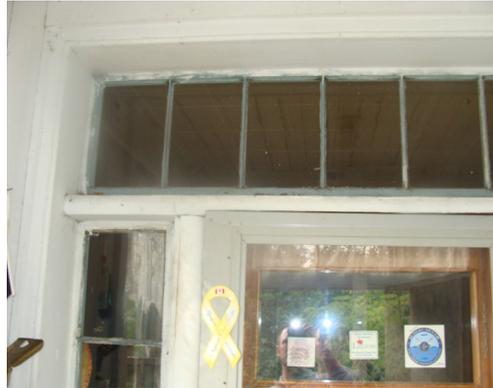
Front porch of the house facing St. Peter Avenue. Main doorway with panel door surrounded by a rectangular glass transom and sidelights. A new porch should be constructed to act as an air lock and a vestibule. Barrier free access should be provided by a ramp located at the side entrance.

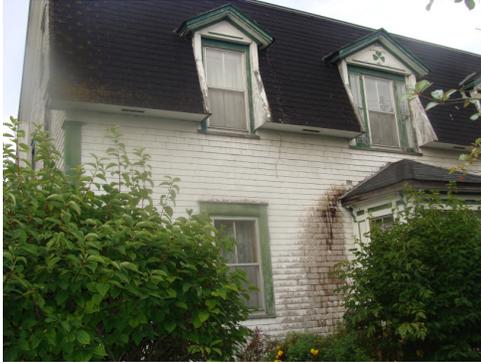
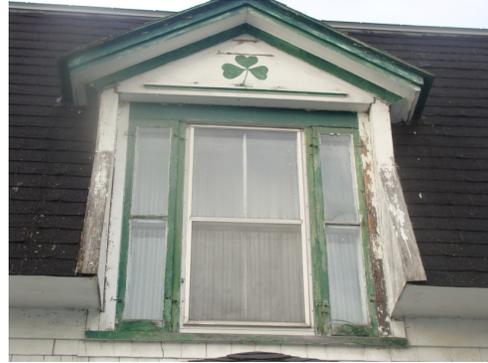
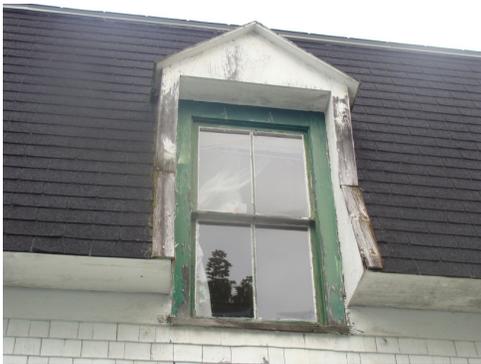
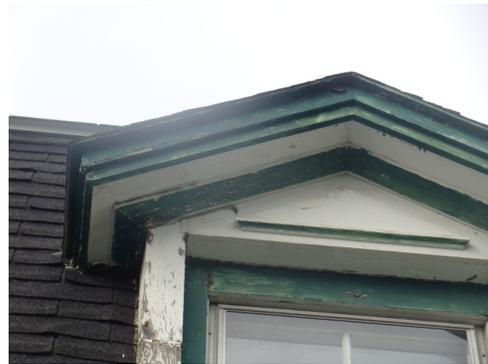
Dormers located in the mansard roof have an appearance of solidity and strength and give a great feeling of height due to the roofline which effectively adds a full storey to the structure. The actual wooden boards attached to both side of the roof edges should be removed when the asphalt shingles will be replaced with cedar shingles.

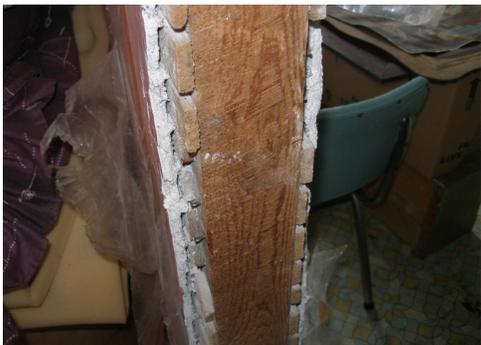
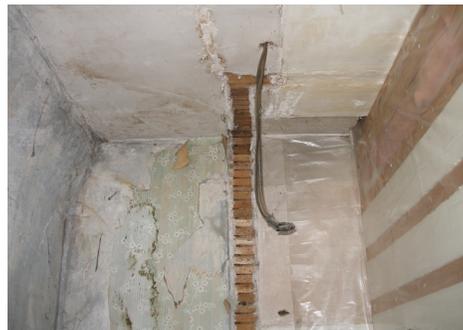
Actual interior partitions made of wood studs with laths and plaster on both side as well as the ceiling. The new partitions could be made of drywall and covered with thin plaster finish.

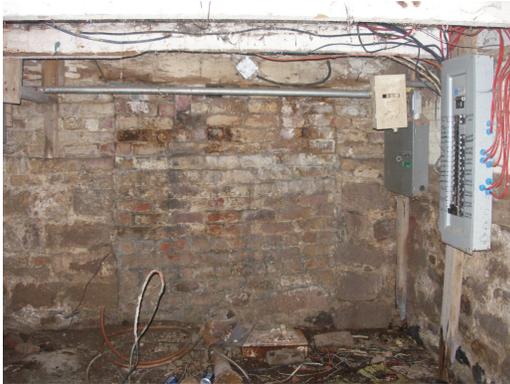
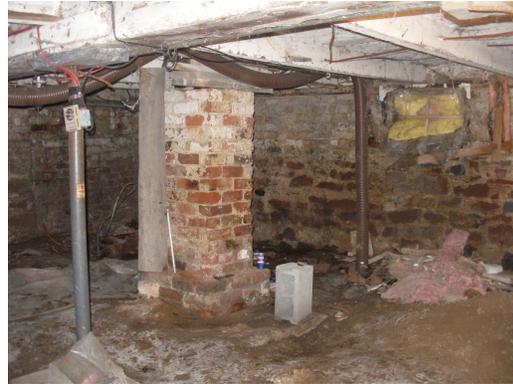
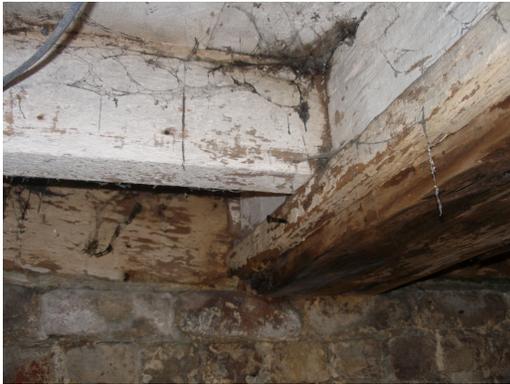
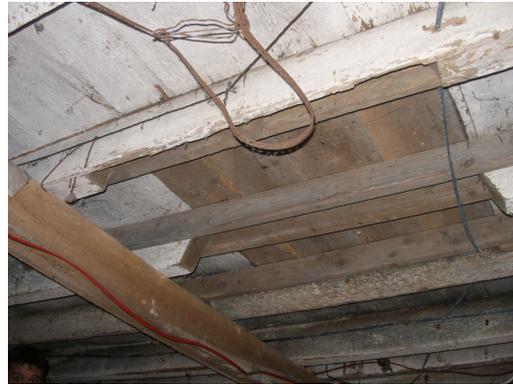
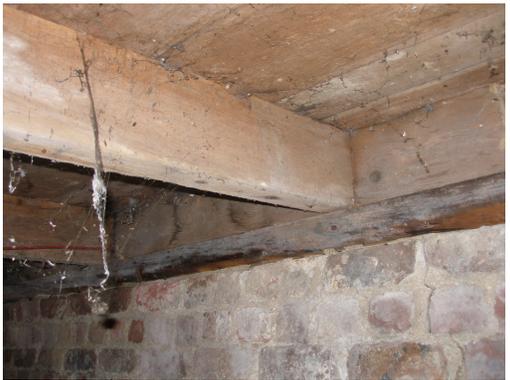
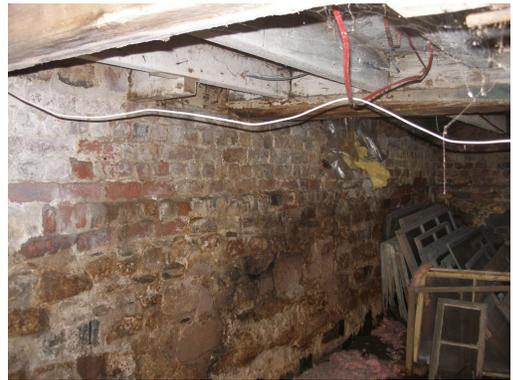
Photographs of the basement showing the field stone foundation (circa 1808) and the brick extension (circa 1858) with the cedar beams and cross-beams. Old chimney brick base and actual electrical panels. This basement as well as the crawl space located underneath the addition will have to be cleaned or replaced by a new reinforced concrete foundation as suggested and detailed in the report..

For sure, the house could be restored on the **actual foundations**, but this approach will have some consequences. Even if these foundations are in place for over 100 years, some movements are still possible which could damage any new interior finish especially plaster and door openings. Also, if the existing foundation stays in place, it will be almost impossible to insulate the basement and the crawl space which will have an effect on the heating costs. In our opinion, the house should be raised in order to provide a **new reinforced concrete foundation** and the house can then be levelled at the same time. Also a brick veneer (for the original portion) and granite stone veneer (for the addition) can be applied outside in order to reflect the original foundation work. By doing this approach, the basement can be insulated, heated and be used as service and/or storage spaces. A detailed proposed cross-section of a new reinforced concrete foundation is attached if this approach is considered.
