Our File No.: 423-14-C

Subject: Structural Condition Review Doucet Hennessy House, Bathurst (NB) _Rev 2

DOUCETT-HENNESSY HOUSE BATHURST, NEW BRUNSWICK

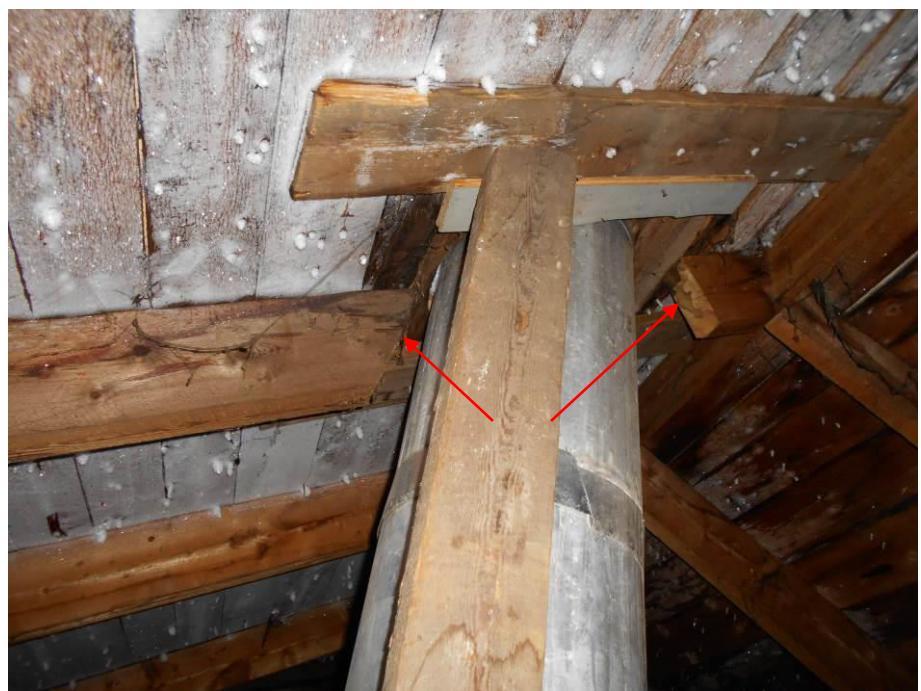
- 1. Structural member in the attic area were cut at the junction of the back addition of the property. This is believed to have been done to allow the chimney pipe to pass through at this area. Although it is not a critical matter, minor reinforcement/repairs of this area are recommended in future renovation;

Photo No. 1: Roof Rafter Cut at chimney

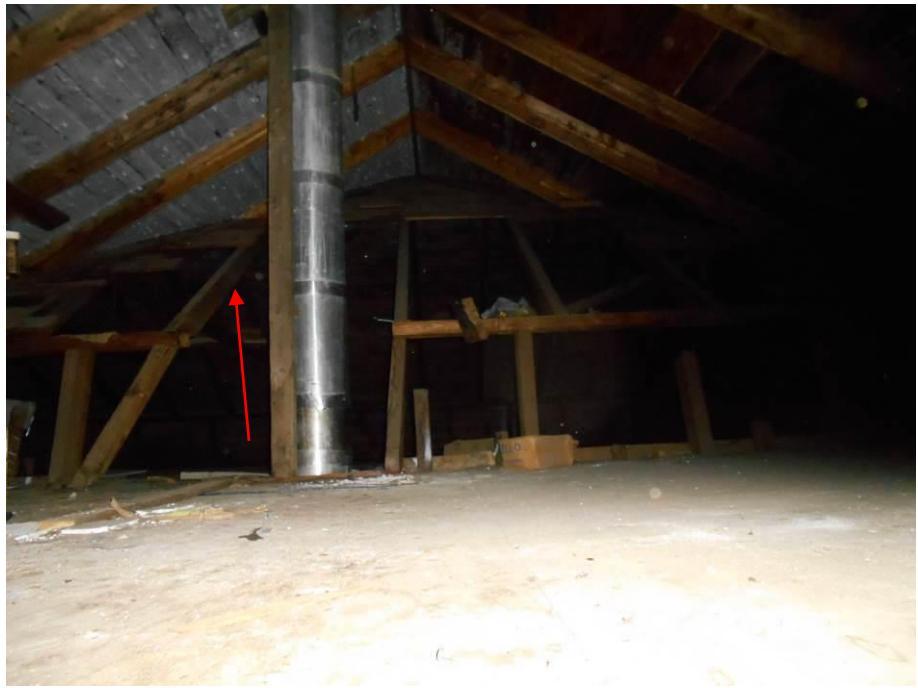
Photo No. 2: Roof Rafter Cut at Chimney

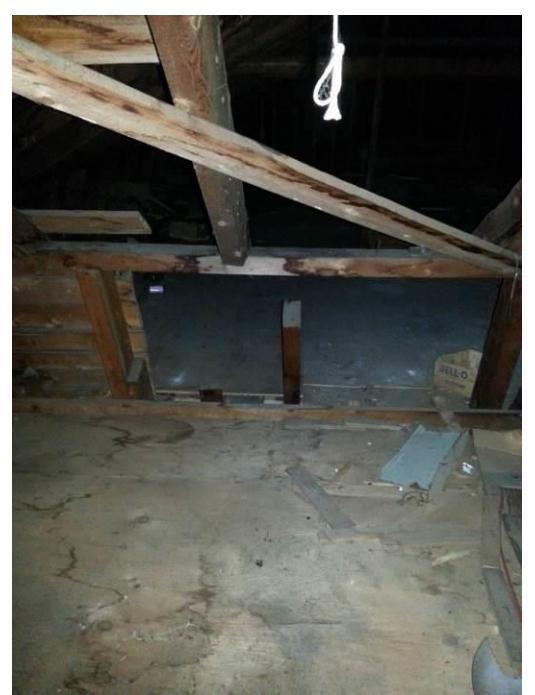
Photo No. 3: Cut Wood Framing at the Junction of the Building Addition

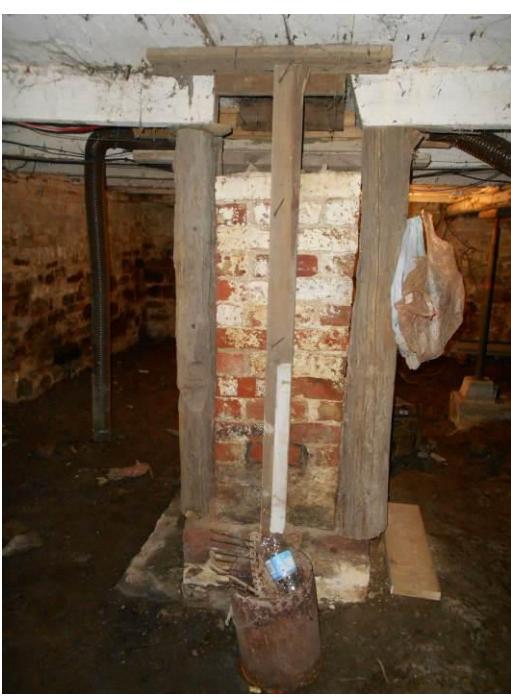
Photo No. 4: Questionable Framing around Basement Chimney

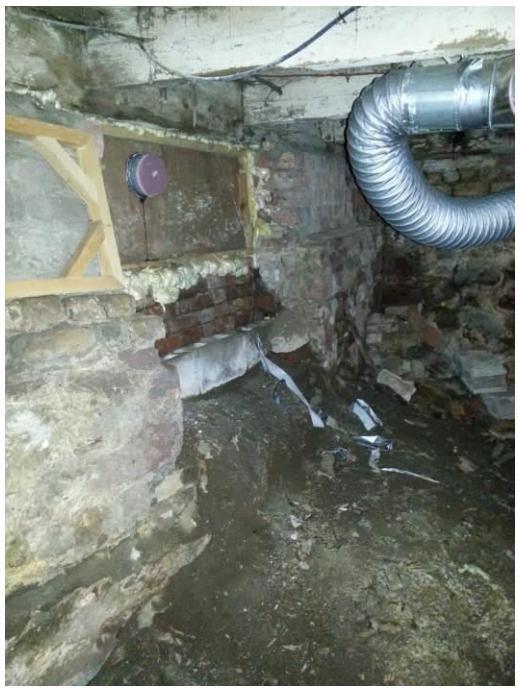
- 4. In addition to the lateral crack, the field stone foundation has some areas of local distress. These area are believe to be past openings that were block and are not performing adequately. These areas should be repaired locally if a new foundation is not poured. We would recommend to install a new concrete foundation and we strongly believe that a new foundation would be the most economical and practical option to repair the deficiencies in regards to the field stone foundation.

Photo No. 5: Old Opening in Basement Foundation

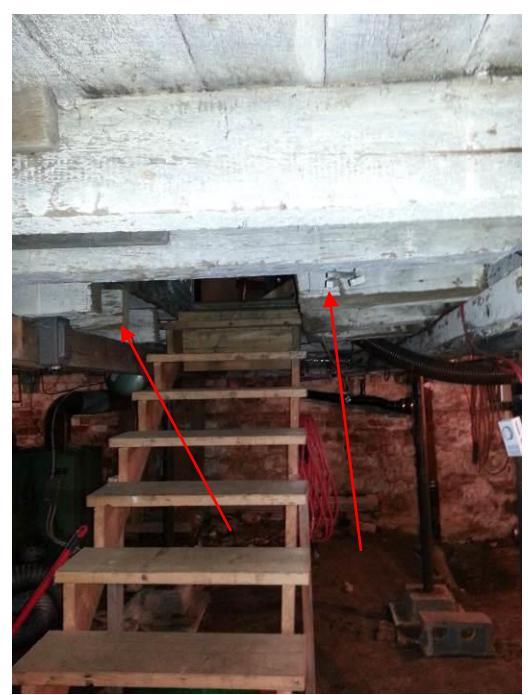
- 2. Some floor joists and/or beams located in the basement do not have proper support. We strongly believe that adding some additional posts in some area of the basement would rectify this situation;

Photo No. 6: Unsupported Joist beside Basement Stair

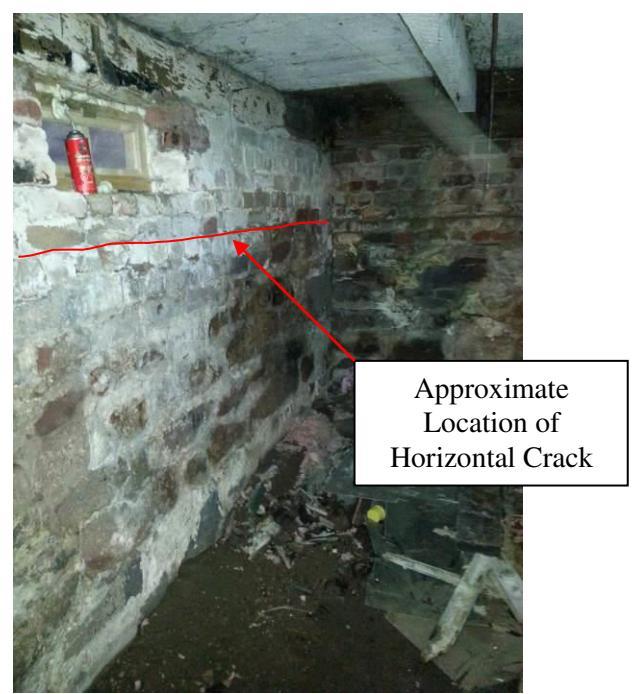
- 3. Field stone foundation shows signs of distress in some areas. A lateral crack has occurred which is a sign that lateral pressure of the earth is causing the mortar between field stones to crack, reducing the structural capacity of the foundation. Although it is not critical at this point, we strongly believe that a new concrete foundation will be required in the future to sustain the structural loads of the property.

Photo No. 6: Foundation Horizontal Crack Suggesting an Excessive Lateral Load on the Foundation

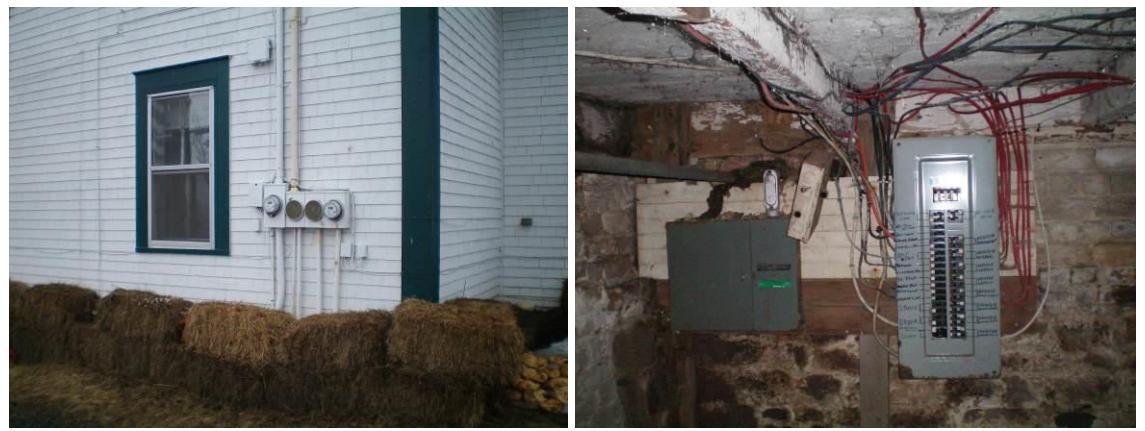
The main electrical service enters the building from an overhead utility line. The service entrance consists of two (2) 200A 120/240V 1ph service masts. One supplies a 200A 4-jaw meter to a 200A distribution panel located in the basement. The second service mast supplies a 100A 120/240V 4-jaw 3-meter base. From that meter base, two meters are blanked with unused panel and disconnect in the basement. The third meter supplies power to a rented apartment in the building. The service entrance is in very poor shape and is not salvageable.

Exterior View of Meters

Basement View of Distribution

The existing service entrance with all distribution panels and building wiring should be removed. An entirely new service entrance with new distribution, wiring and communication should be installed as per the new building design requirements. The work could be done directly by a licenced electrician to render the installation acceptable to current codes and standards.

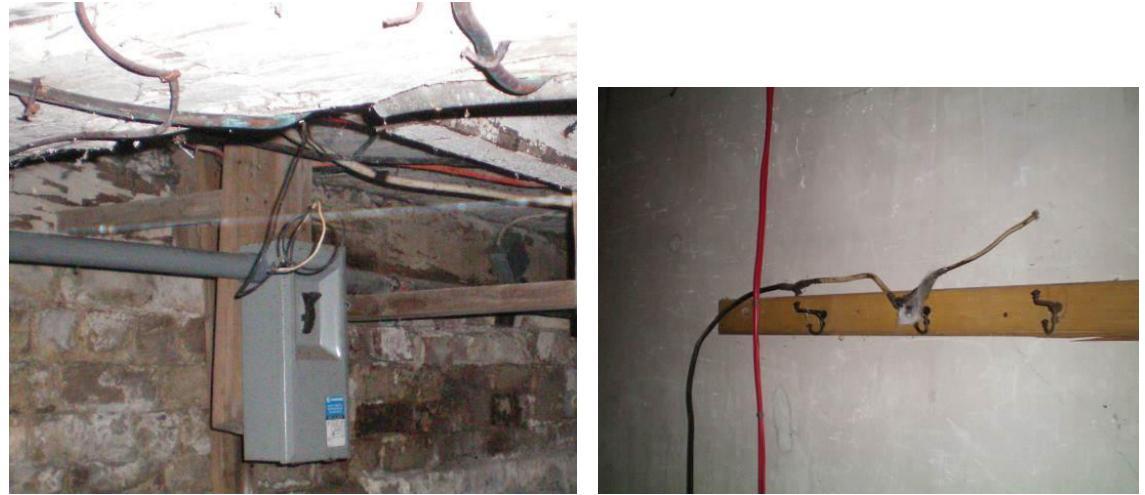
The building wiring consists of lumex copper wires (paper and tar covered) and NMD plastic insulated. Both materials are approved building materials. However, the building wiring has seen many modifications over the years and proper care or disposal of unwanted cables has been neglected and will require inspection and removal. Some may have power and may be harmful.

Disconnect

Abandoned Wire

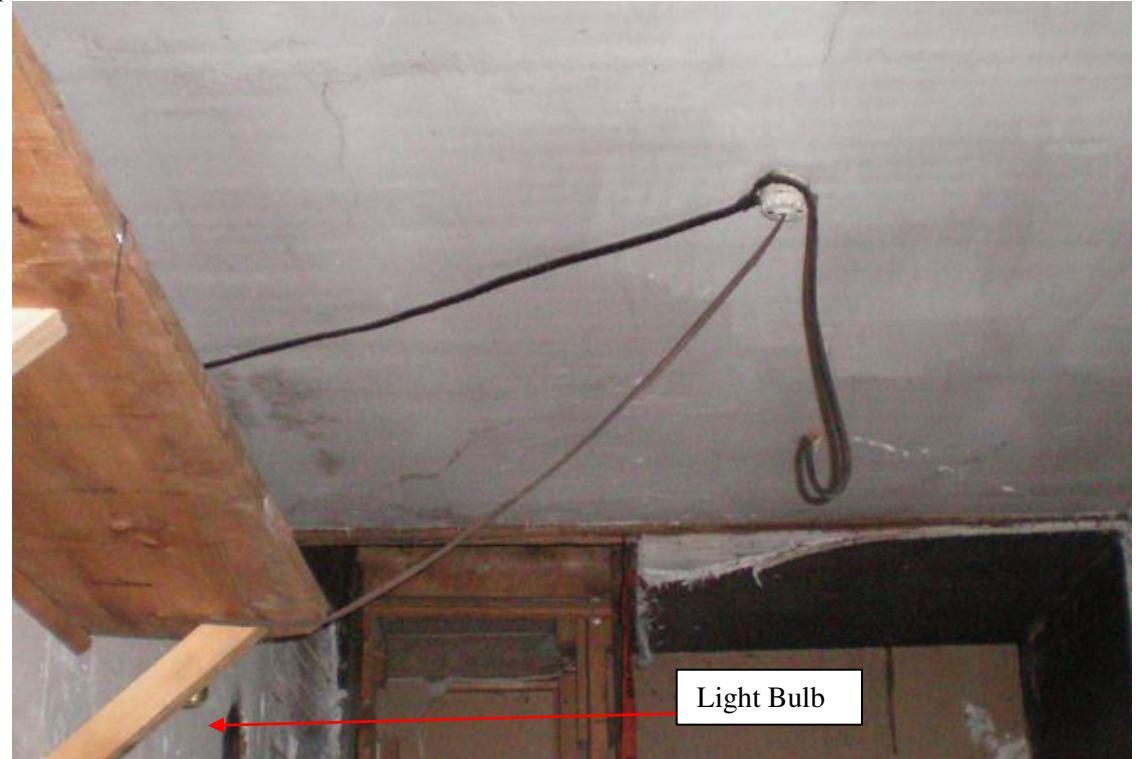
The existing lighting system consists of surface fluorescent and incandescent luminaires. The exterior lighting consists of incandescent wall luminaires. Some lights are wired without boxes on porcelain holders.

Typical Light Wired without Box

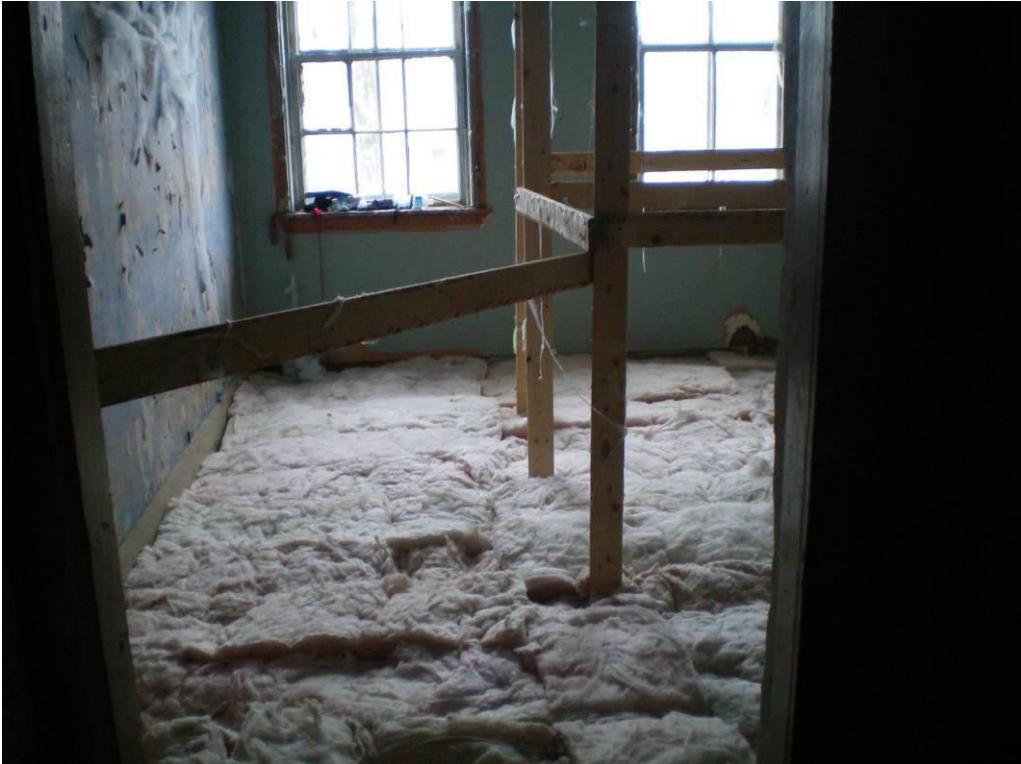
The existing heating system consists of baseboard heaters. Some sections of the building on the upper floor are not heated and are covered with insulation.

Upper Floor with Insulation to Reduce Lower Apartment Heat Loss

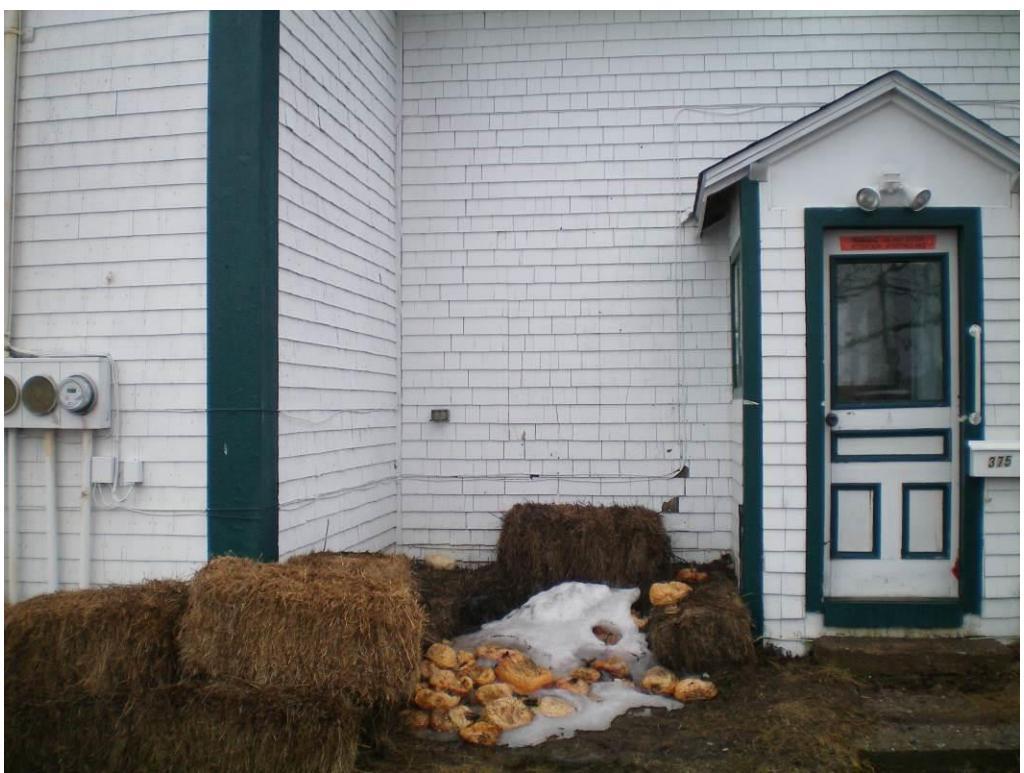
The existing communication system consists of an exterior surface telephone cable entry.

Telephone Line Running on the Exterior Wall to Individual Phones

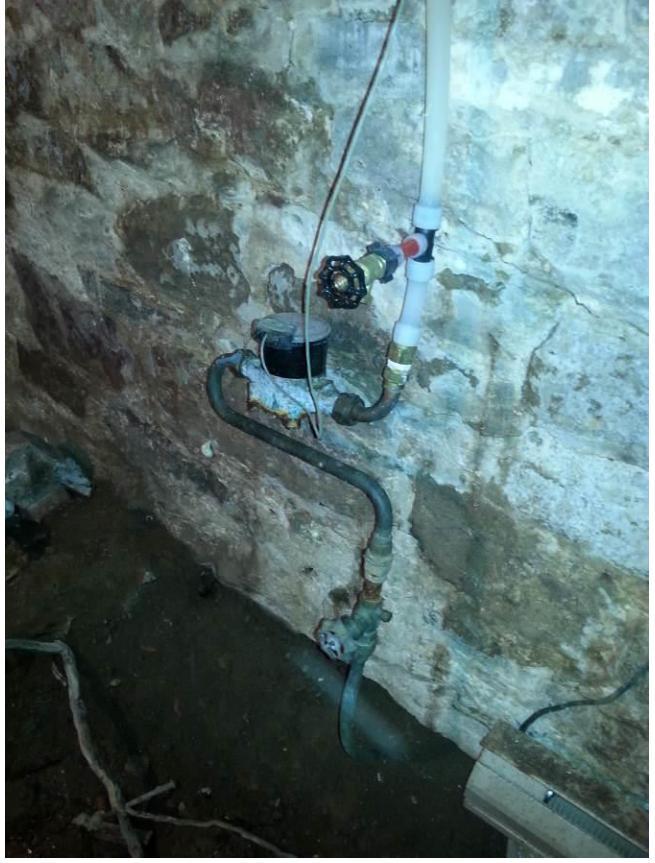
The existing water entrance is not as per current applicable codes. The water entrance shall meet CSA B64-10.1-07, meaning the water entrance should be complete with a dual type backwater preventer. The main shutoff gate valve and meter have reached the end of their service life and should be replaced. A wye strainer should also be installed. The sequence of the water entrance should be as follows:

Existing Water Entrance

- 1. Main Shut-off Valve;
- 2. Wye Strainer;
- 3. Water Meter;
- 4. Backflow Preventer.

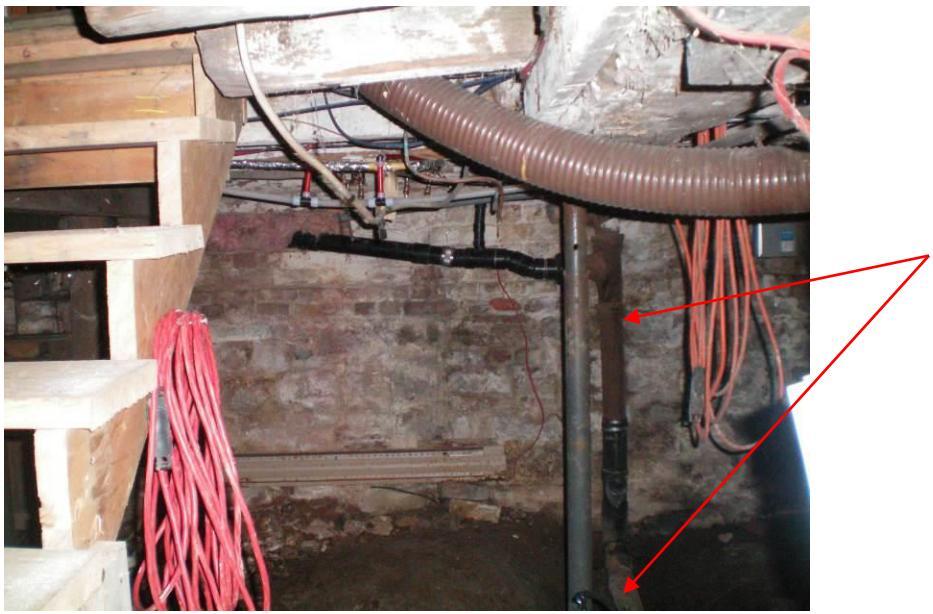
Cast iron sanitary piping located in the basement is in poor condition and has reached the end of its service life. We strongly suggest replacing said piping with new ABS type piping.

Cast Iron Piping in Poor Condition

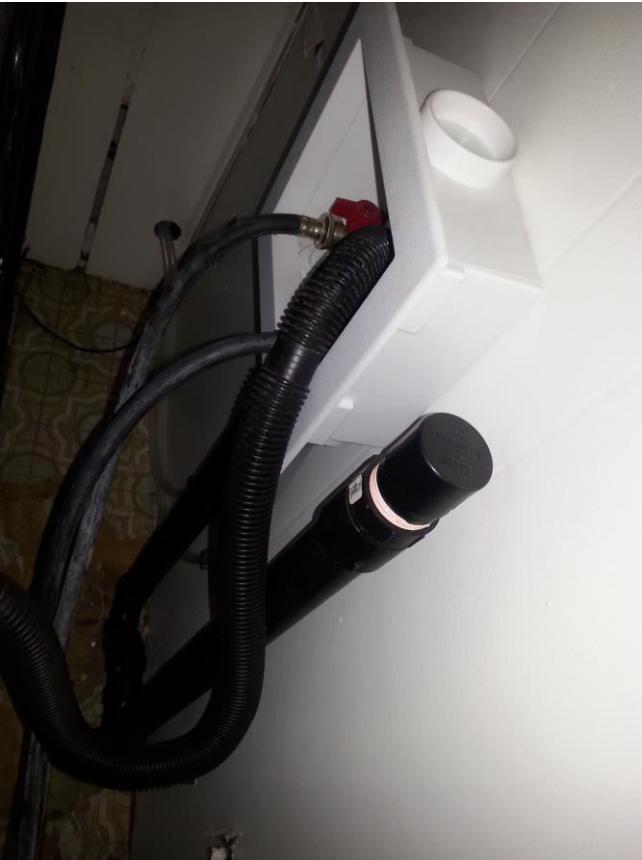
Although most sanitary pipe ventilation were not visible, an in-line ventilation was observed on the washer. This is not acceptable as per plumbing code and proper sanitary pipe ventilation should be provided.

Acceptable Sanitary Pipe Ventilation

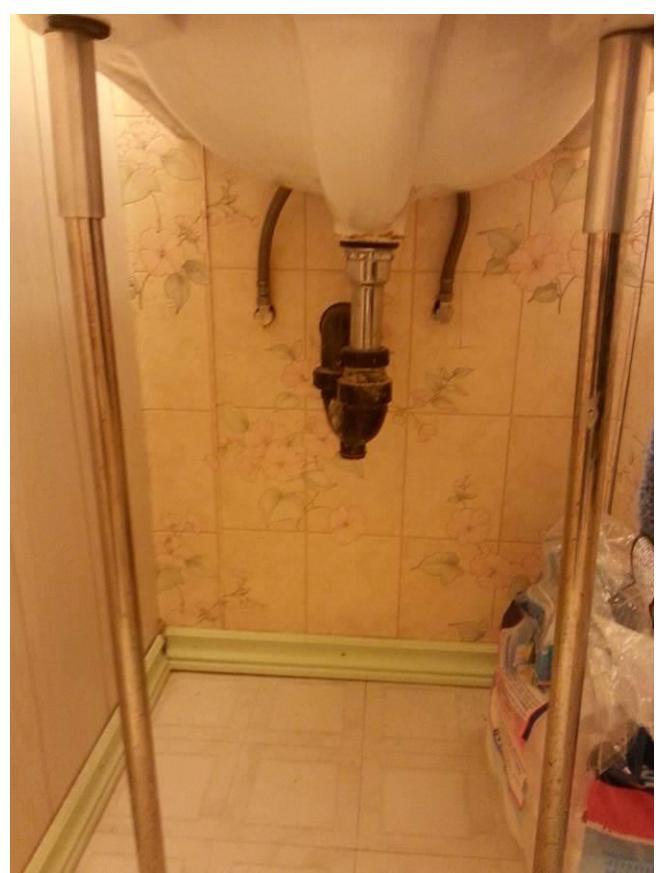
Most fixtures in the building are old but still function. We strongly suggest incorporating new fixtures in a future renovation project. Some fixtures were found to have no closet stops, which makes it hard to perform regular maintenance on such fixtures.

Fixtures without Closet Stops
